Survey of the east half of the south west - quarter  
of Section 13 township 1 south Range 14 east.

Surveyed Jan. 16th 1900 For John Truax

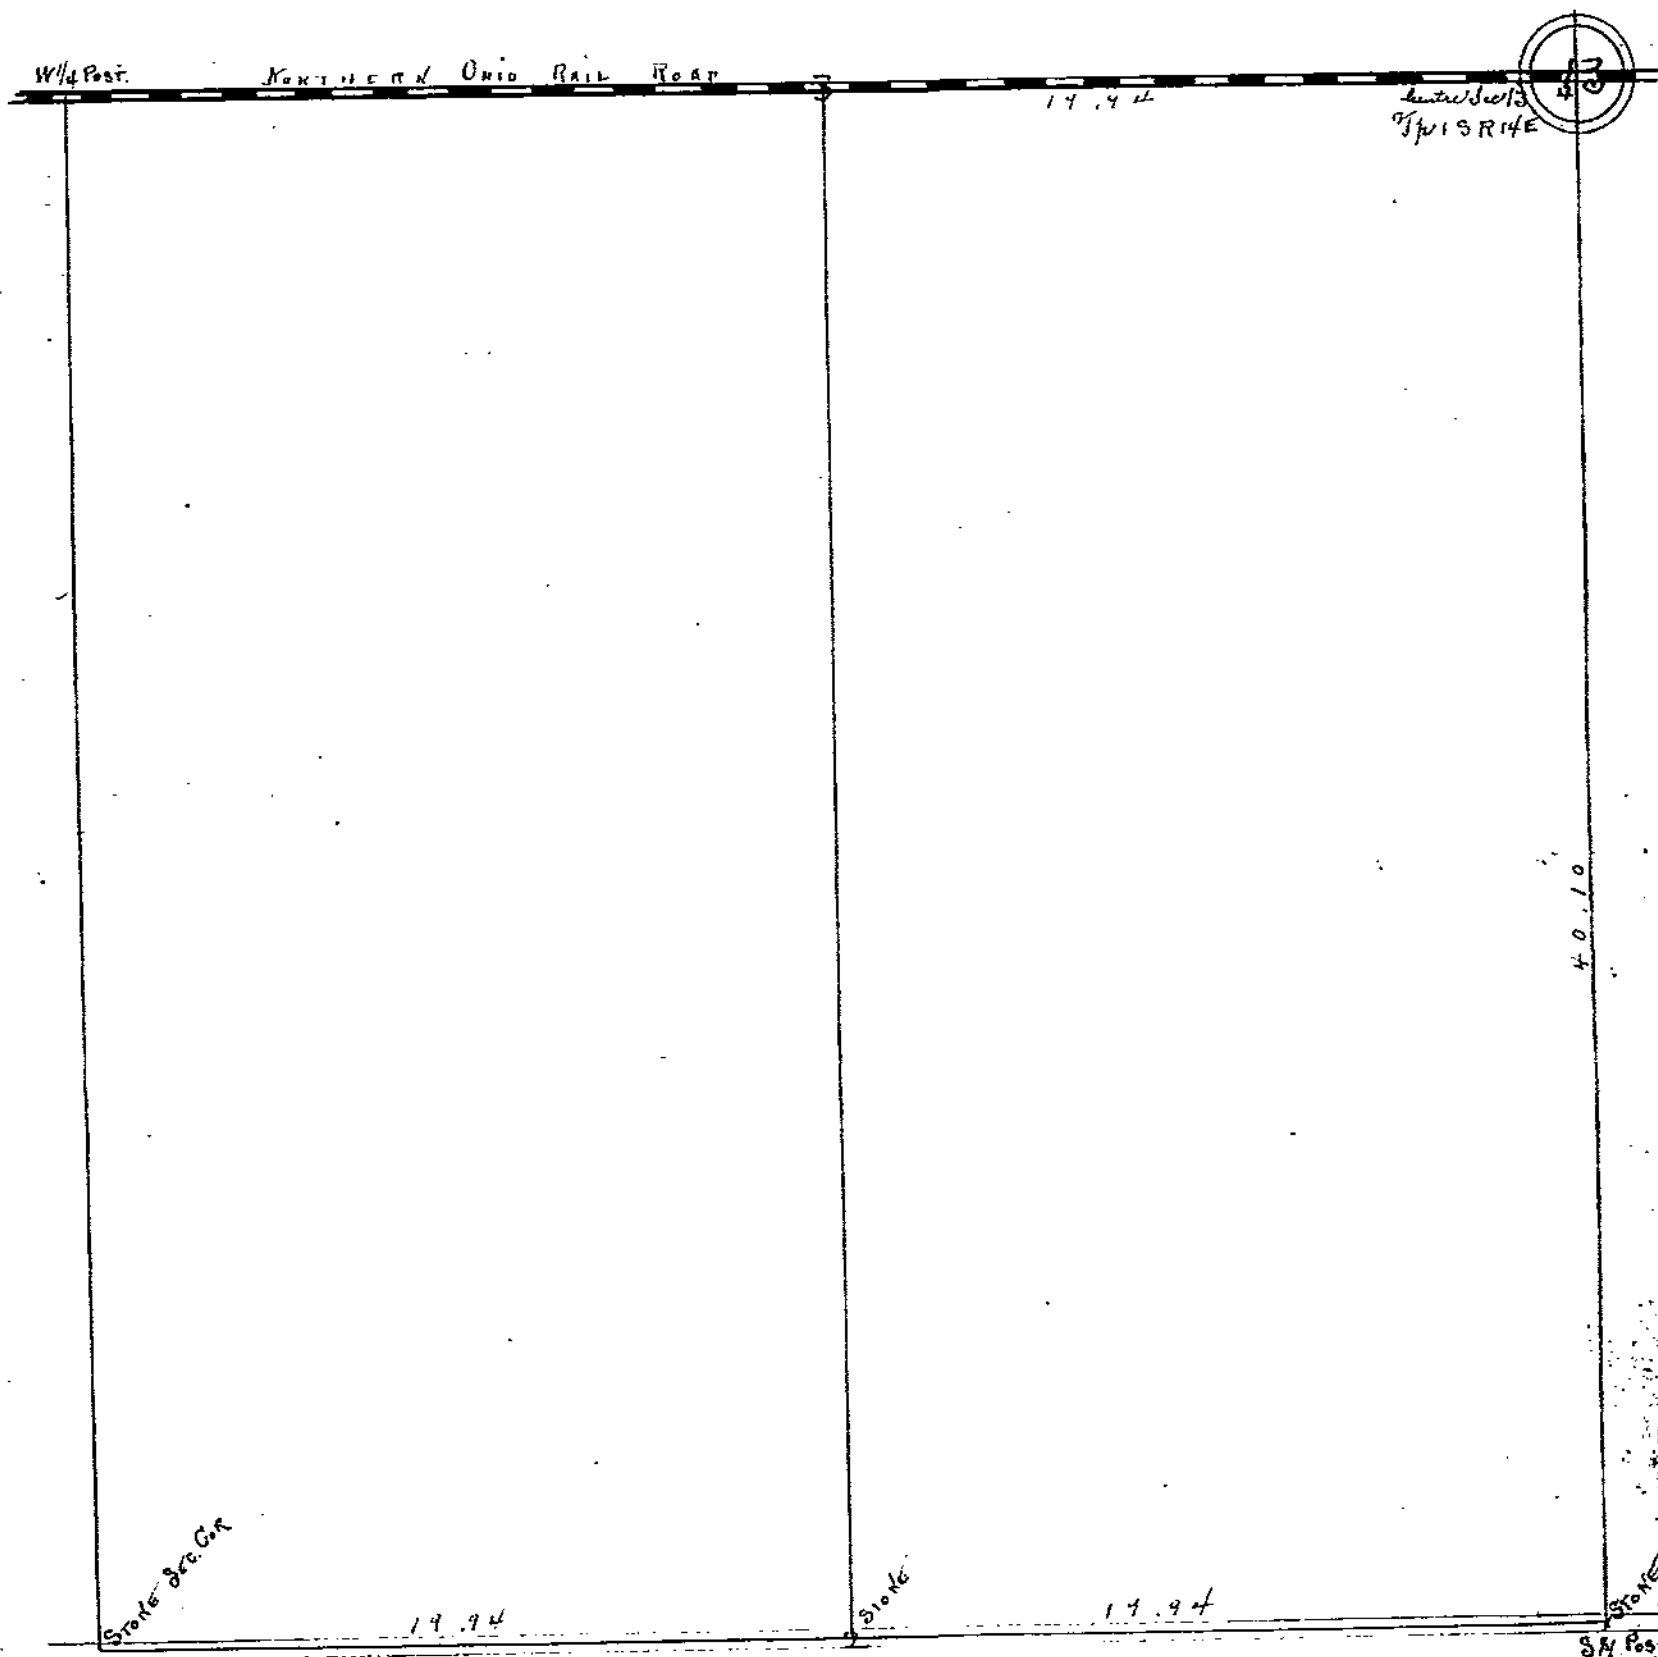
No 324.

At 1. S 1/4 Post STONE 13 Walnut 10 N 28 3/4 W 26

Beech 36 S 11 1/2 E 53

At 2. STONE Elm 10 S 66 1/2 W 59 1/2

13 Walnut 4 N 11 1/4 E 29 1/2

At 3 Stone in centre of Northern Ohio RR broken sewer pipe under stone

At 4 Centre of Sec 13 Twp 1 south Range 14 east

and stone in centre of Northern Ohio R.R.
